Zayante Area Sediment Source Study

Swanson Hydrology & Geomorphology

January 31, 2001

ZAYANTE AREA SEDIMENT SOURCE STUDY

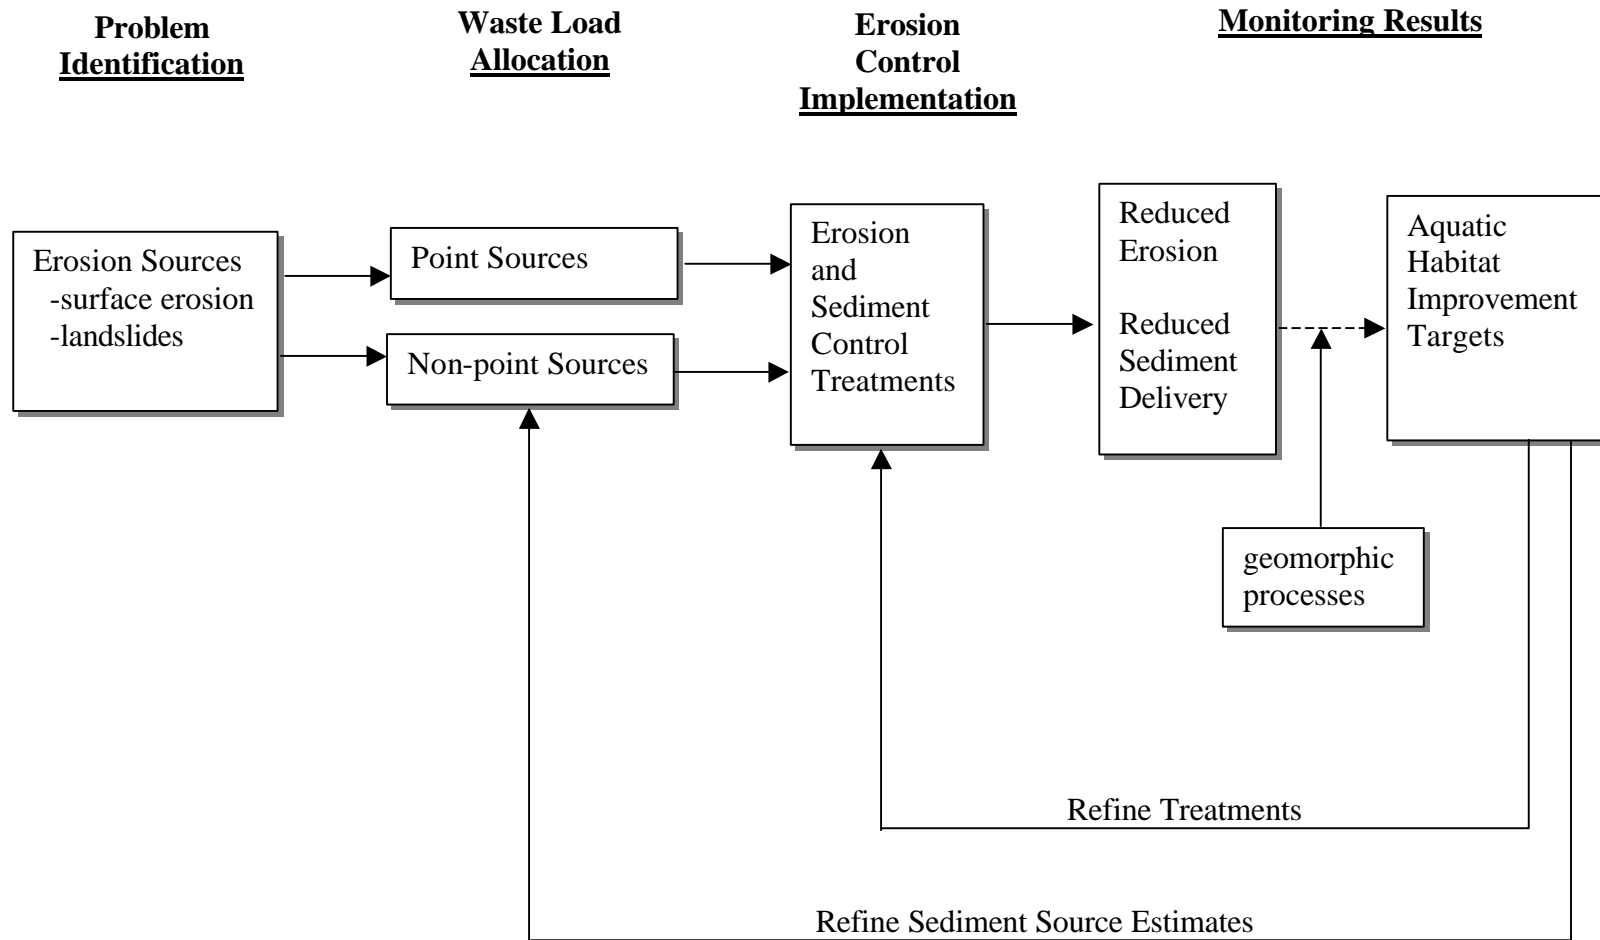
Figure 1.2: Flowchart describing the “phased” approach to a TMDL for the Zayante Study Area

As stated above, the designation of the San Lorenzo River as an impaired water body necessitates improvement under the Clean Water Act. For habitat impairing sediment, the TMDL process begins with identification of pollution problems (in this case sediment sources), followed by quantification of sediment sources, then design and implementation of an erosion control program to reduce sediment input and achieve “target” aquatic habitat conditions to gain “compliance”. Monitoring must be provided through the implementation period to adjust management activities and to measure progress towards target goals (**Figure 1.2**). Estimates of sediment sources can also be refined as data is collected.

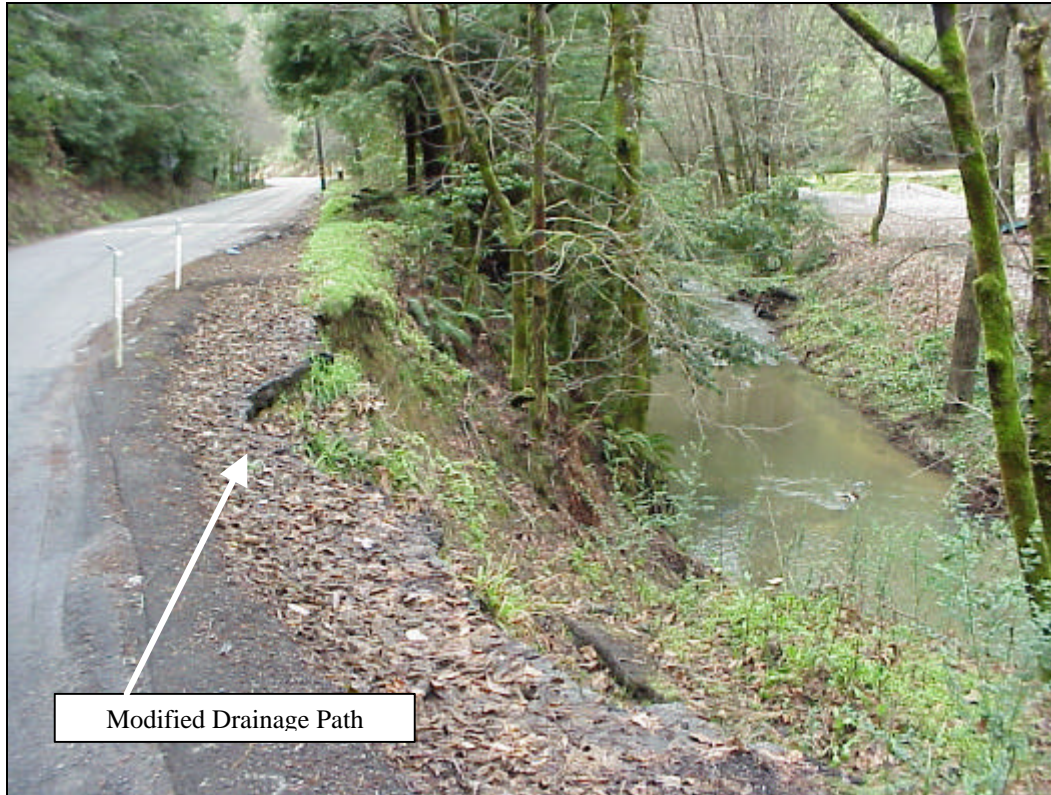
Figure 2.1. Road Shoulder and Streambank Failure in Road-confined Inner Gorge Area of Zayante Creek. (Failure is likely due to sheet flow erosion and saturation of streambank material resulting from a plugged culvert.)

along canyon floors and steep inner gorge slopes cause channel realignment resulting in direct delivery of sediment to streams (**Figure 2.1**).

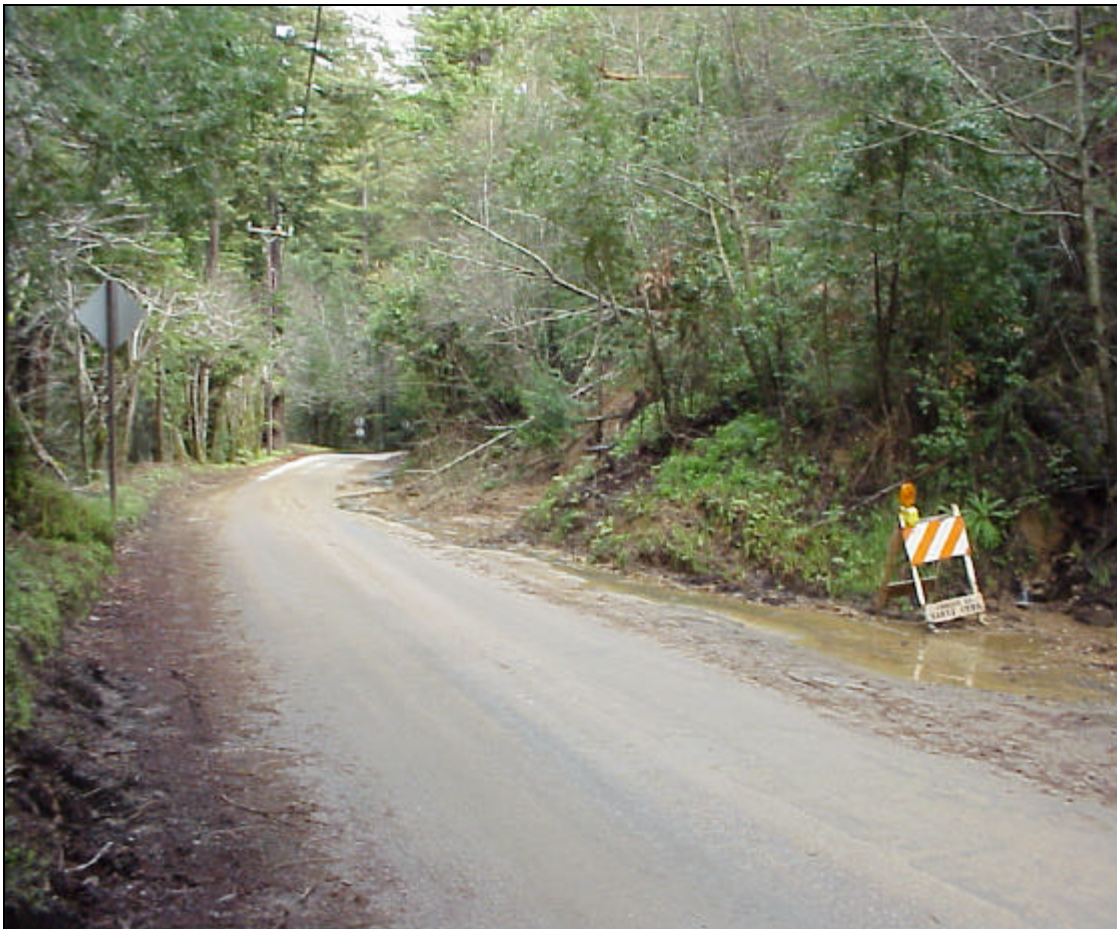
Figure 2.2. Roadcut Failure and Landslide Over East Zayante Road. Inside ditch and cross culvert are overwhelmed by the sediment load, which forces sheet flow over the road surface.

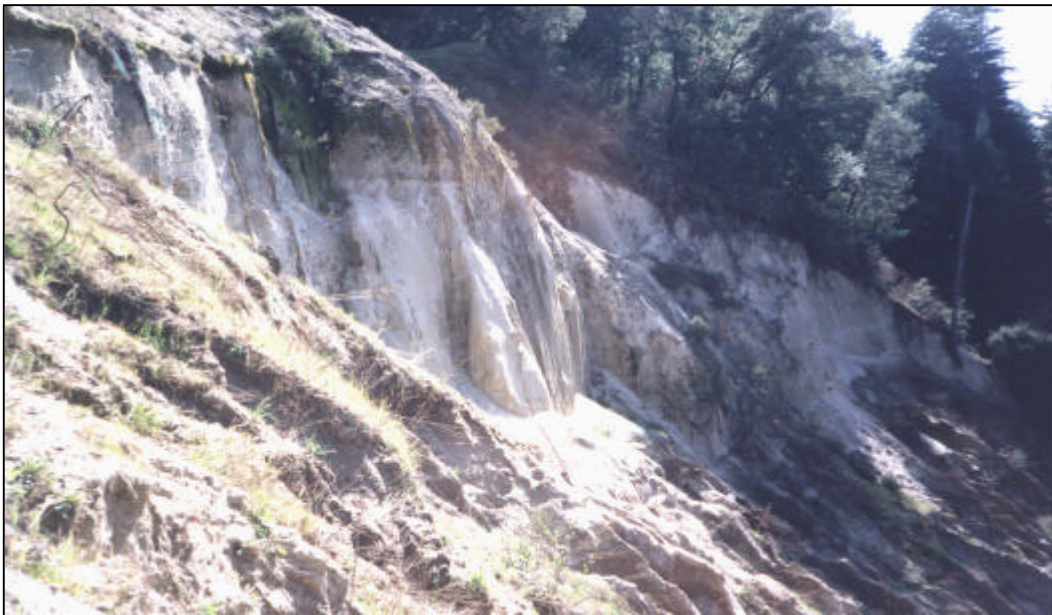
Figure 3.2: Eroding Road Cuts on Bean Creek Road Within Santa Margarita Sandstone

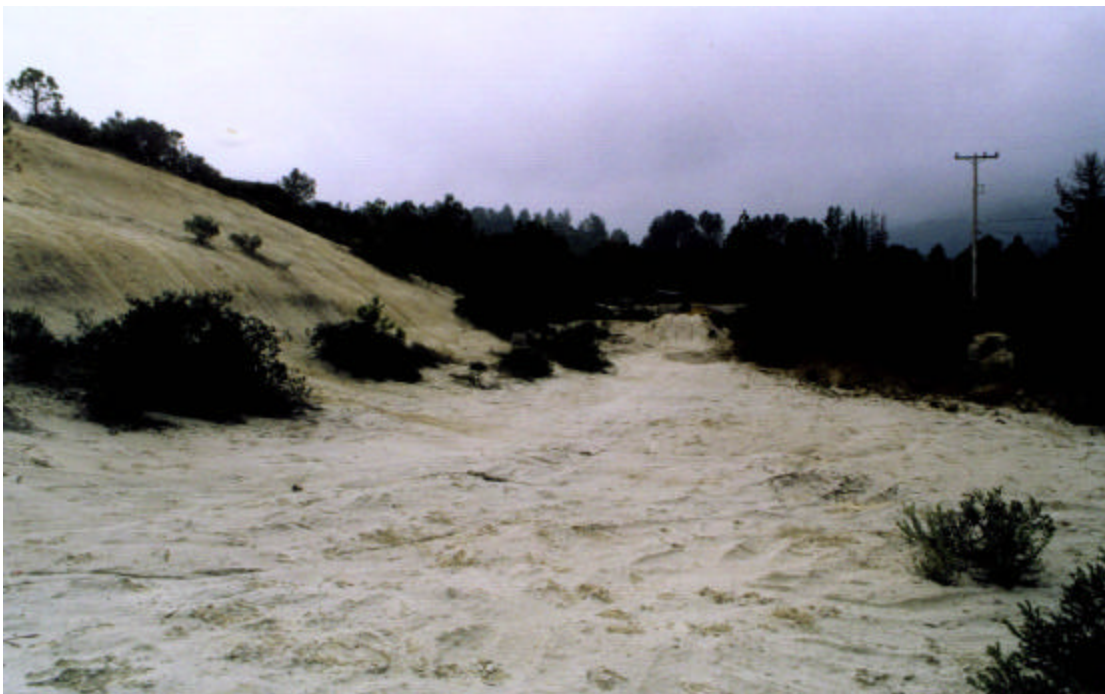
Excessive erosion problems still exist at Rancho Rio (**Figure 3.3**), specifically a large gully of weathered Santa Margarita sandstone in a drainage swale next to Quail Hollow Middle School. Drainage improvements to the school parking lot, playing fields and roof runoff, along with an engineering feasibility study to stabilize the large gully would be necessary to reduce this site as a significant fine sediment source.

Figure 3.3: Exposed Santa Margarita Sandstone Above Quail Hollow School

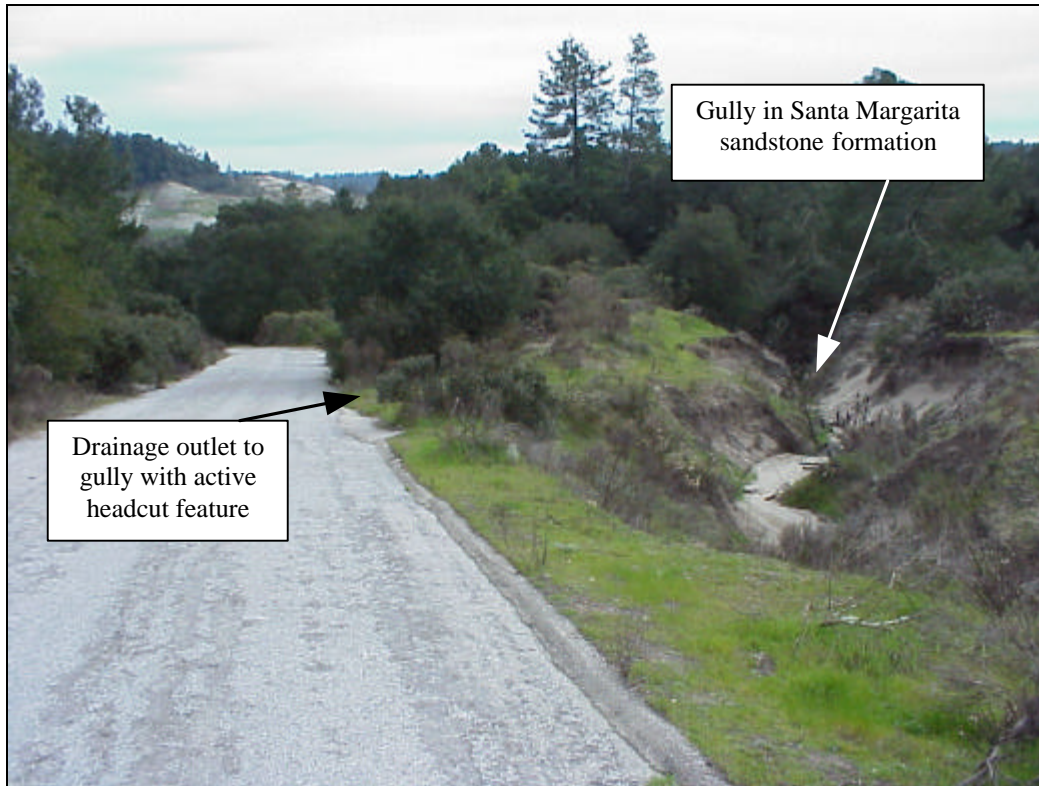
along the road has resulted in the development of a large gully in Santa Margarita sandstone adjacent to the road (**Figure 3.5**).

Figure 3.5: Gully Development Adjacent to McEnery Road

An engineering feasibility study needs to be conducted to determine the best approach to manage runoff from the road and adjacent land uses. Gully stabilization and revegetation would be required to reduce the excessive fine sediment supply.

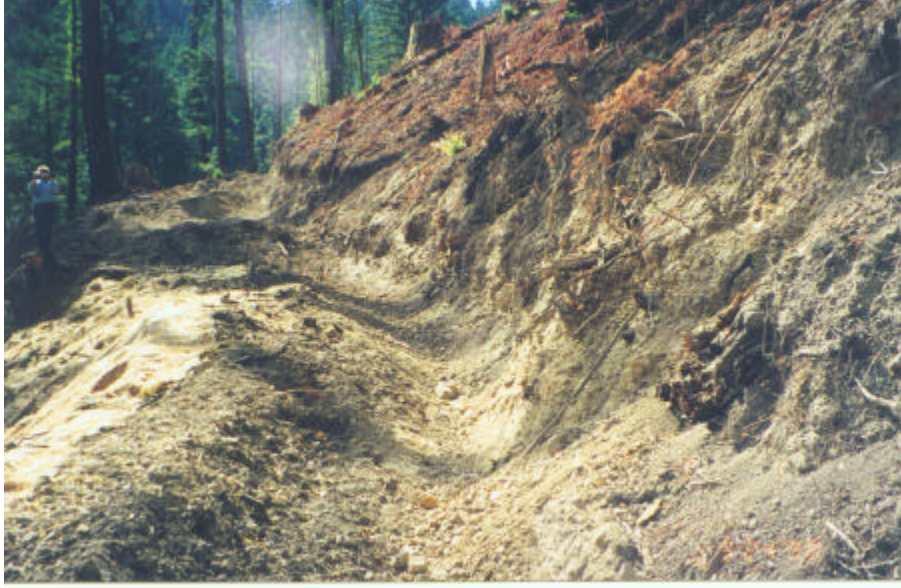
Figure 4.1: Recently Built Timber Harvest Road in the Fritch Creek Drainage that was cited for a grading violation by Santa Cruz County.

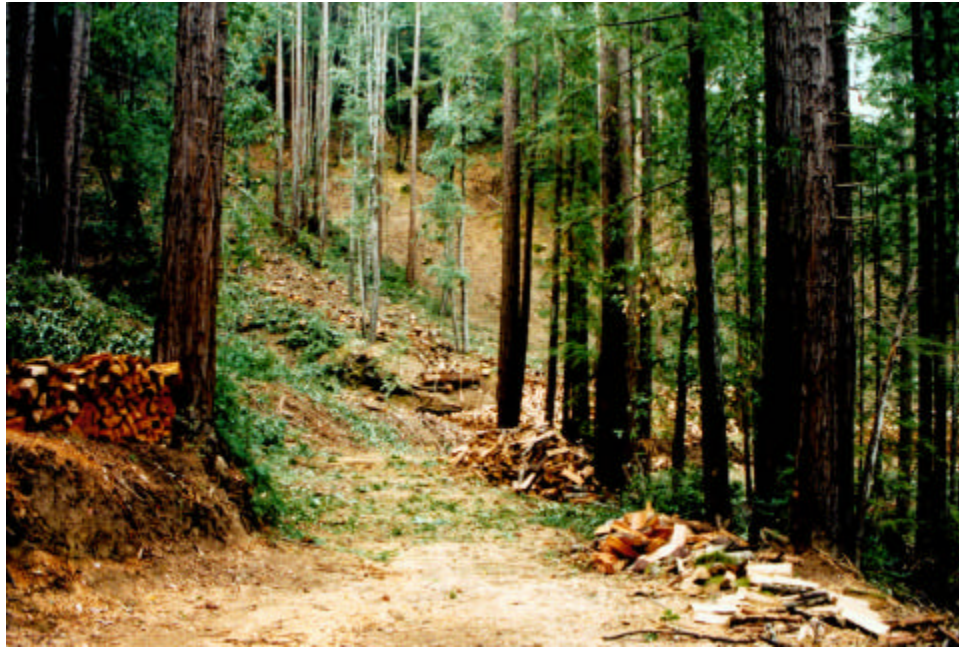
Figure 4.3: Example of a Timber Harvest Road Managed by the City of Santa Cruz in the Zayante Creek Drainage Basin.

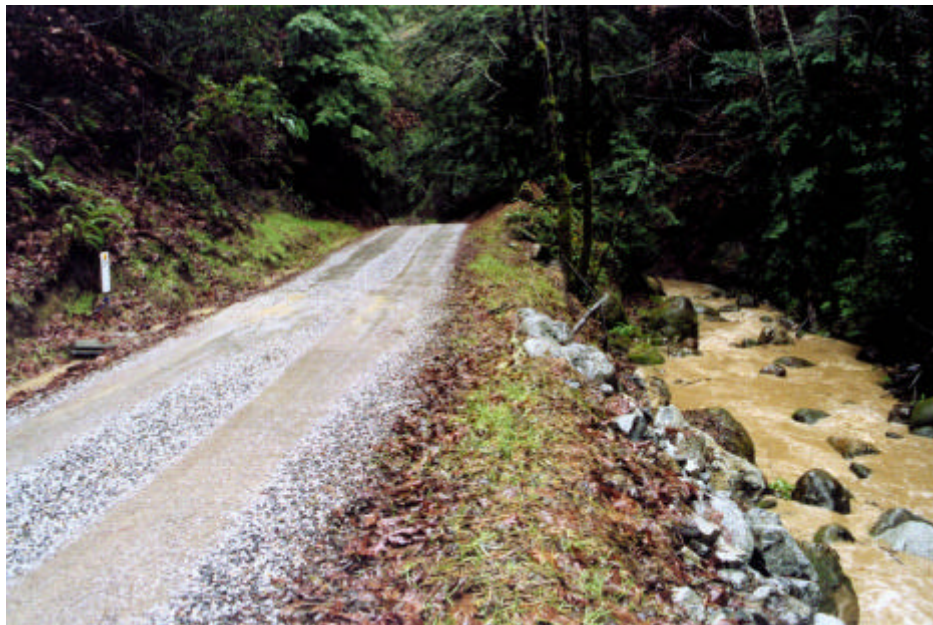
Figure 4.4: Example of a Gravel Road Within the Inner Gorge on Kings Creek.

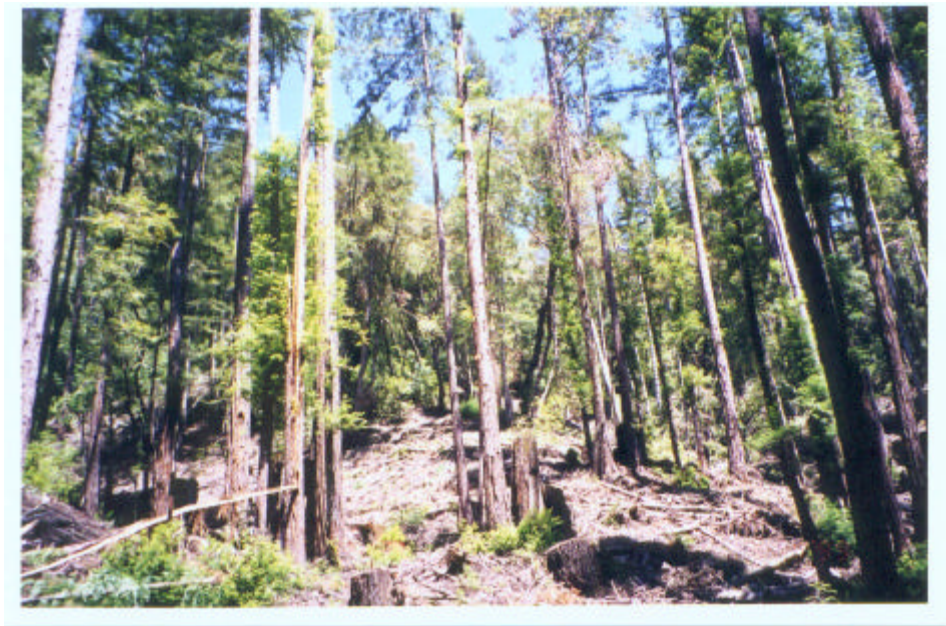
Figure 4.6: Example of an Active or Recent Timber Harvest Area in the Zayante Study Area.

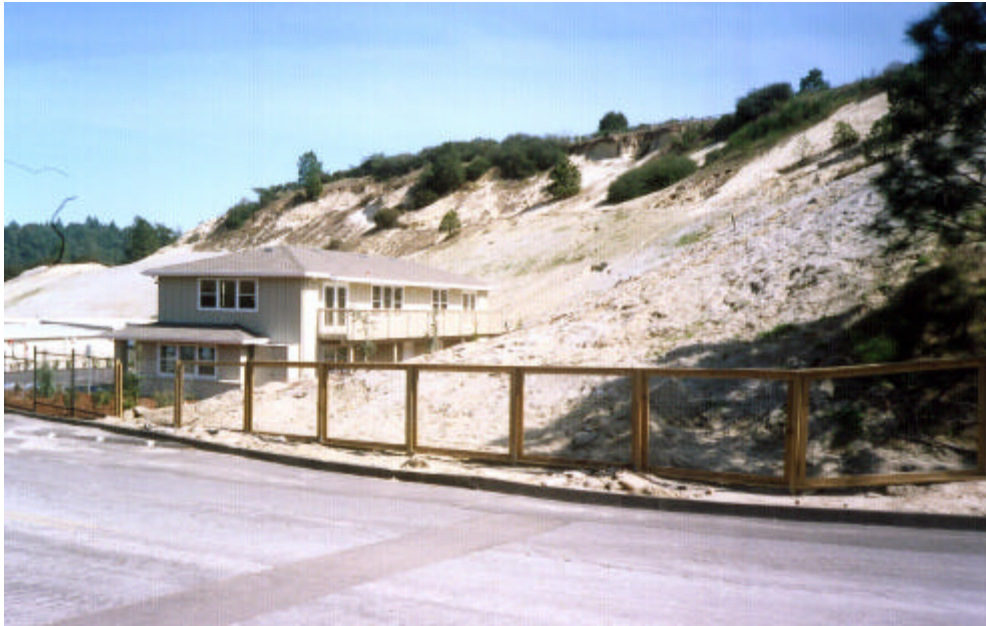
Figure 4.7: Example of Recent Land Clearing for Residential Development (Other Urban and Rural Lands).
