**FINAL REPORT:
COUNTY OF SANTA CRUZ STREAM CROSSING INVENTORY AND FISH PASSAGE
EVALUATION**

**Prepared for the
County of Santa Cruz Public Works Department**

**By
Ross Taylor and Associates**

March, 2004

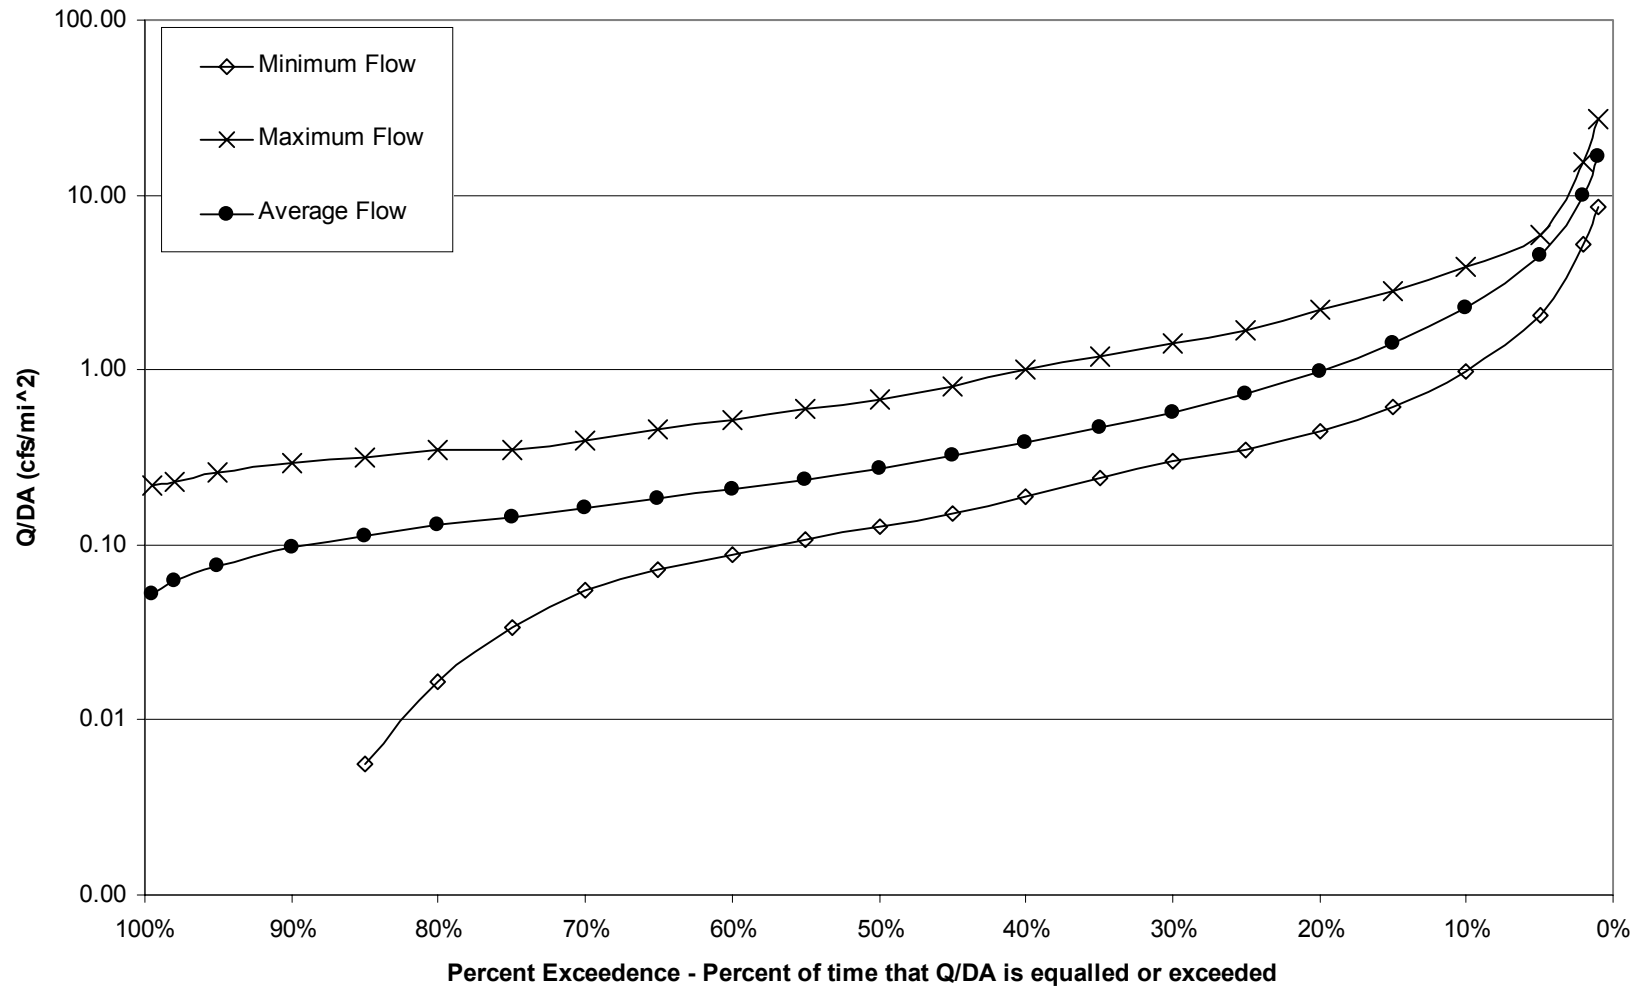
Flow Duration Curve for Santa Cruz County Based on USGS Gauges
